Benterud School

SURFACE PREPARATION CASE STUDY

CITY OF LØRENSKOG REMOVED PAINT FROM A BRICK/CONCRETE WALL OUTSIDE A SCHOOL IN NORWAY

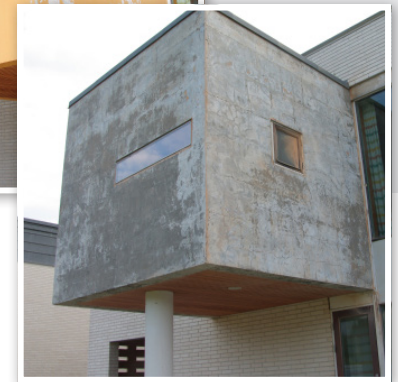
Dry ice cleaning removed the paint, fine layer on bricks and took out loose surfaces (that is normally done by hand) in one operation.

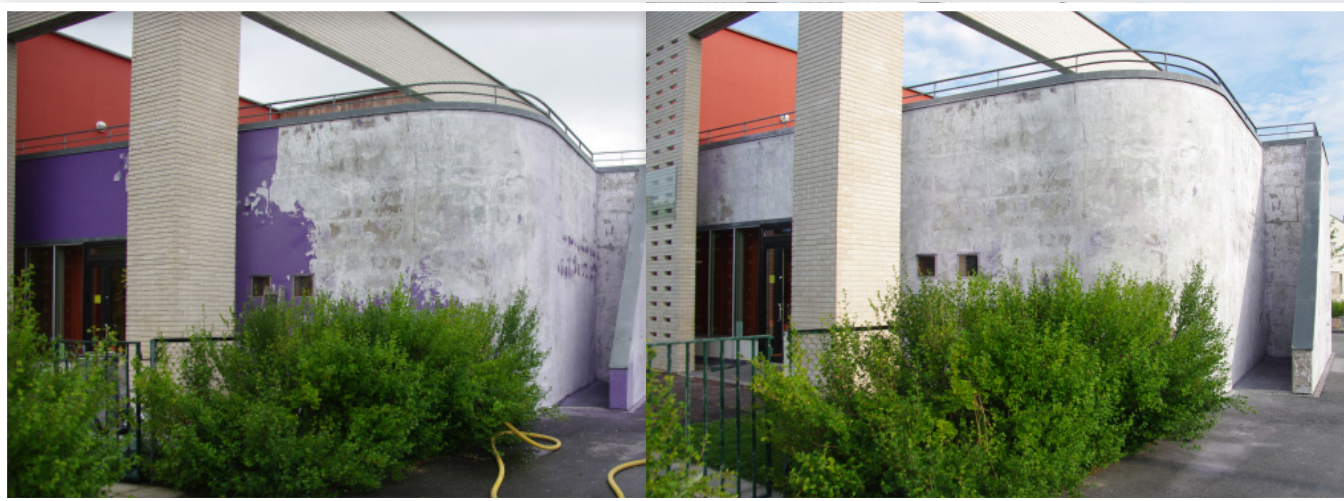
Built in 1999, the primary school had been painted twice in previous years, and was in desperate need of new paint as the last coat was beginning to crack and chip away from the external walls. A decent paint job should last about 10 years, but a surface polish layer on top of the bricks was not allowing the paint to adhere to the surface.

After the paint, polish and loose materials were removed from the three worst areas, a bricklayer was brought in to resurface the walls. Once the walls had dried, Andresen and his team applied a new coating of paint. Since the completion of that part of the school, Andresen has been contracted to complete another 400 square meters (4,300 square feet) of the school using the same dry ice cleaning process.
